SANTA ANA REGIONAL WATER QUALITY CONTROL BOARD
INSPECTION REPORT

8365124001 Darryl Koops Northview Dairy
WDID No. OWNER NAME FACILITY NAME

INSPECTION SUMMARY

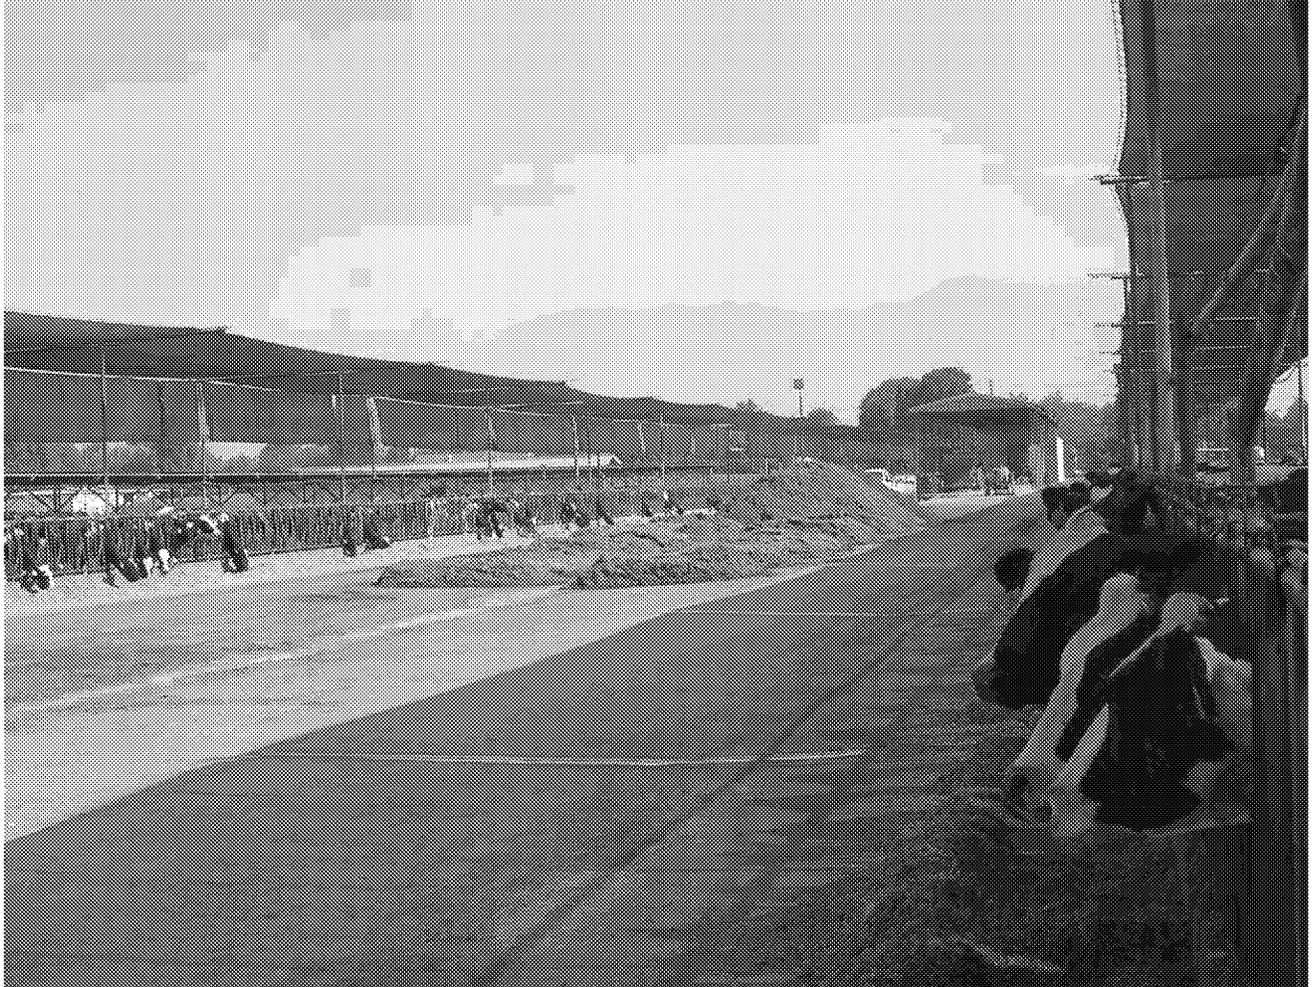
A screened manure pile was observed in eastern flush alley. Numerous other manure stock piles were observed in the western pasture area. These manure piles appeared to be in this area for composting. The corrals are cleaned 3 times/year. Manure is hauled to Kern County. Analysis of manure has been completed as required by dairy permit. Corrals appeared to have been graded for stormwater run-off.

AUGUST 7, 2012 View looking north at eastern flush lane with screened manure solids.

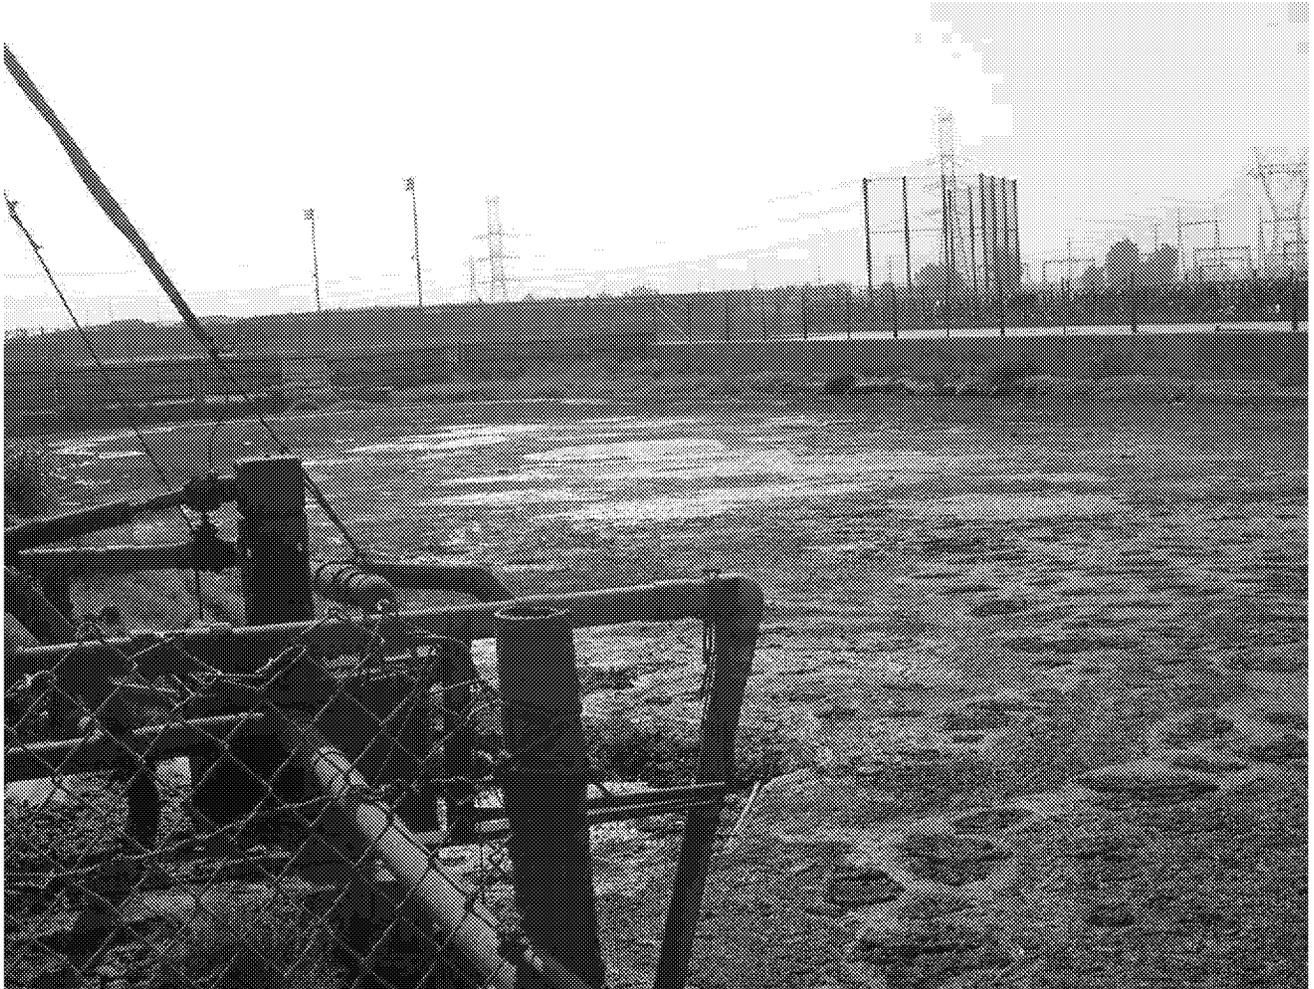
Housekeeping in corrals and feedlanes appears adequate. Pond has not been cleaned in a few years. Excessive manure solids were floating in pond. Extent of excessive solids was such that solids formed floating islands and vegetation had established root systems on the manure islands. Other caked floating manure solids were about 4-5 inches thick. It could not be determined the thickness of the manure islands. A marker was observed in the pond. Freeboard in the pond varied from 1-3 feet. Mr. Koops indicated that the pond was going to be cleaned.

AUGUST 7, 2012 View looking southeast at central pond. Excessive solids floating in pond.

Discussion. Mr. Koops was requested to notify the Regional Board when the removal of the manure solids in the pond had been completed. Direct Mr. Koops to perform rodent control in spillway area. Mr. Koops was requested to submit the results of the manure analysis when completed. Schedule a follow-up inspection to observe correction of violations and verify compliance with permit.

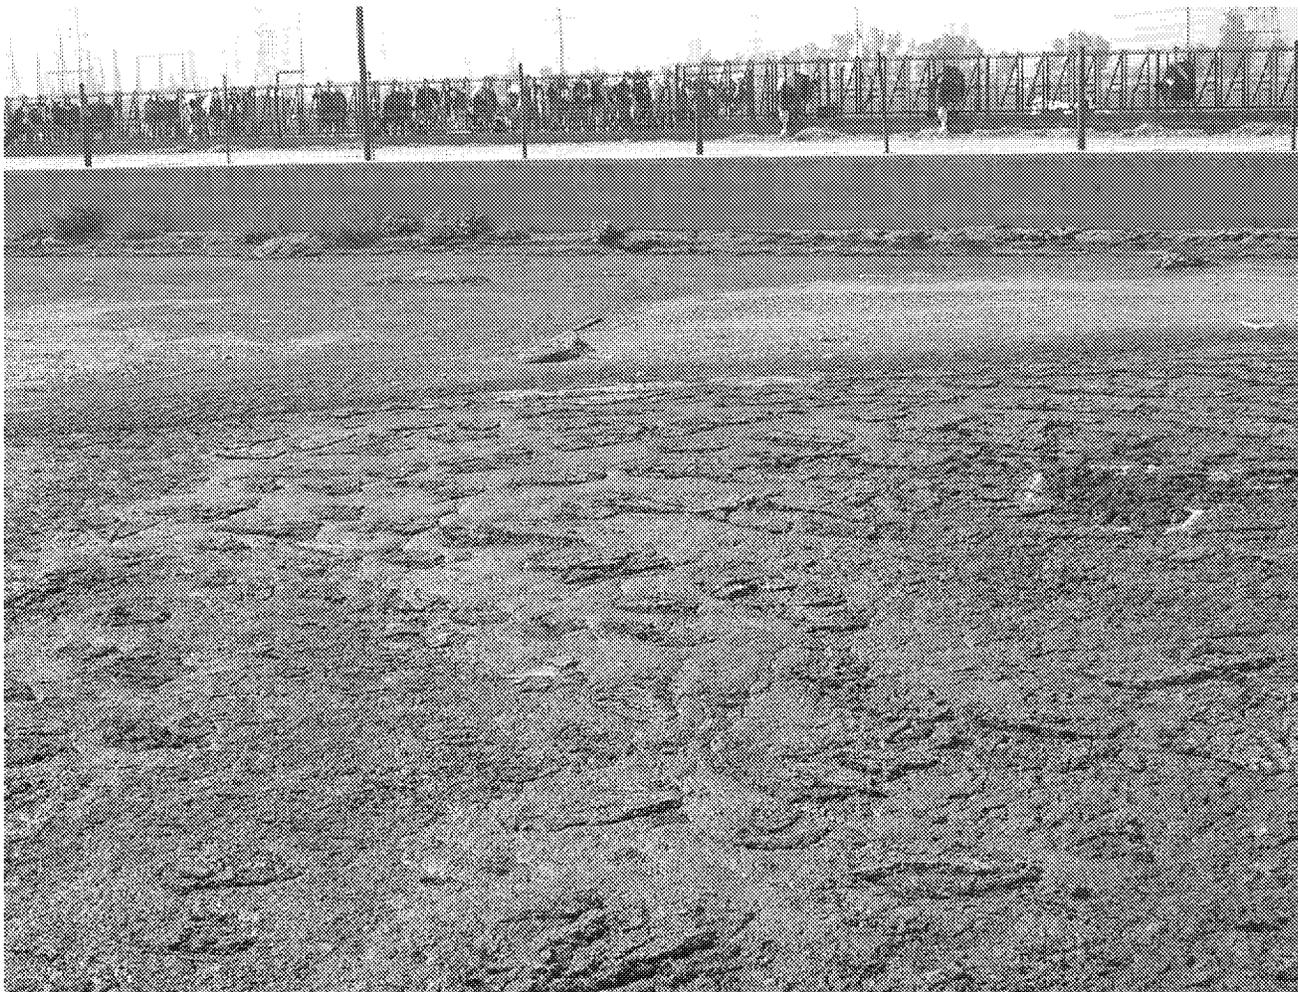
AUGUST 7, 2012 View looking south at central pond. Excessive solids floating in pond.

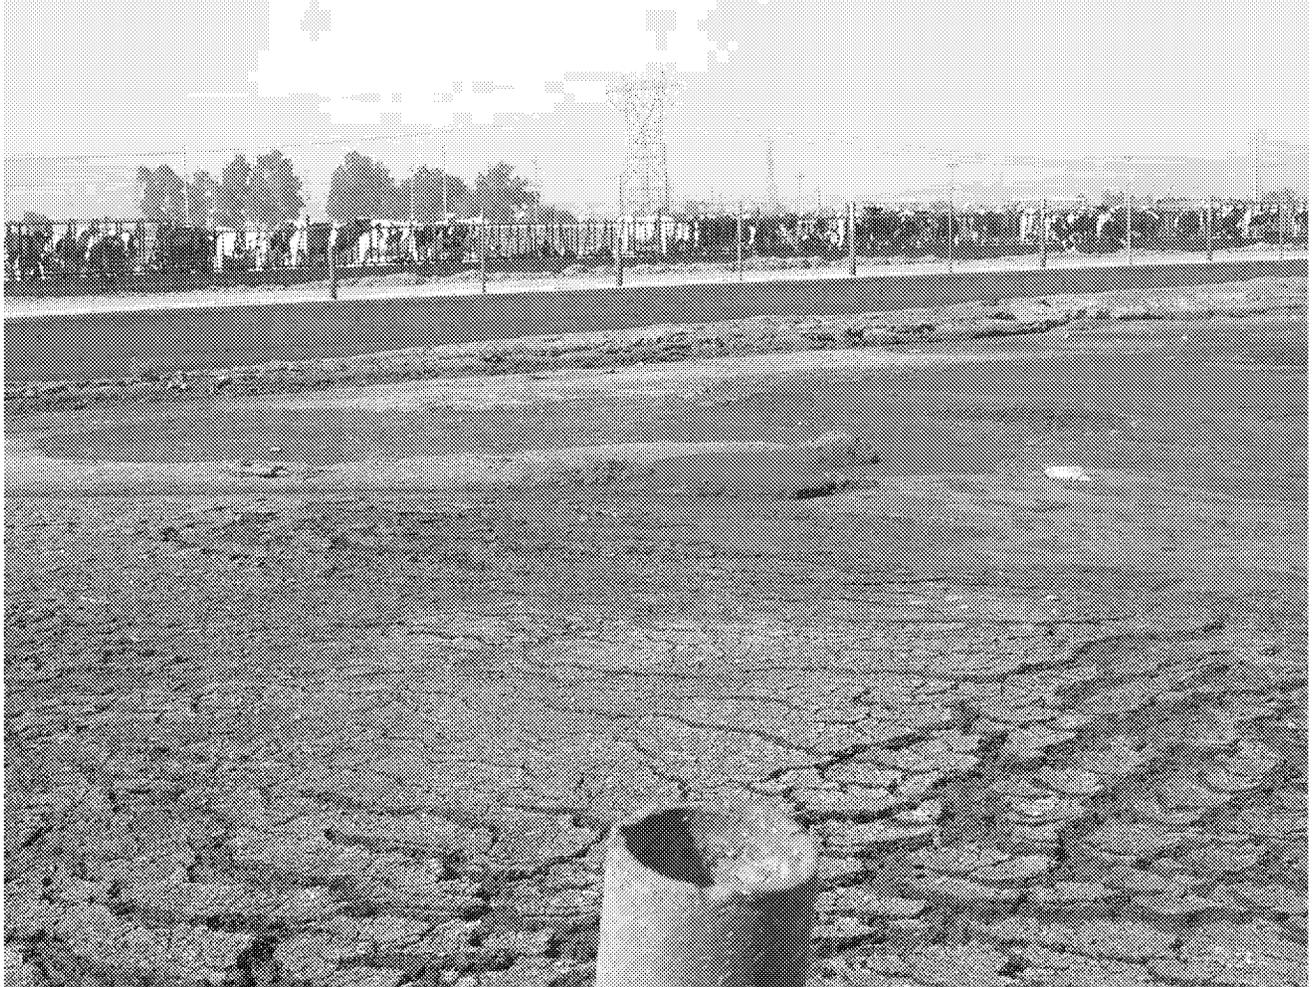
AUGUST 7, 2012 View looking southwest at central pond. Excessive solids floating in pond. Manure island at center.

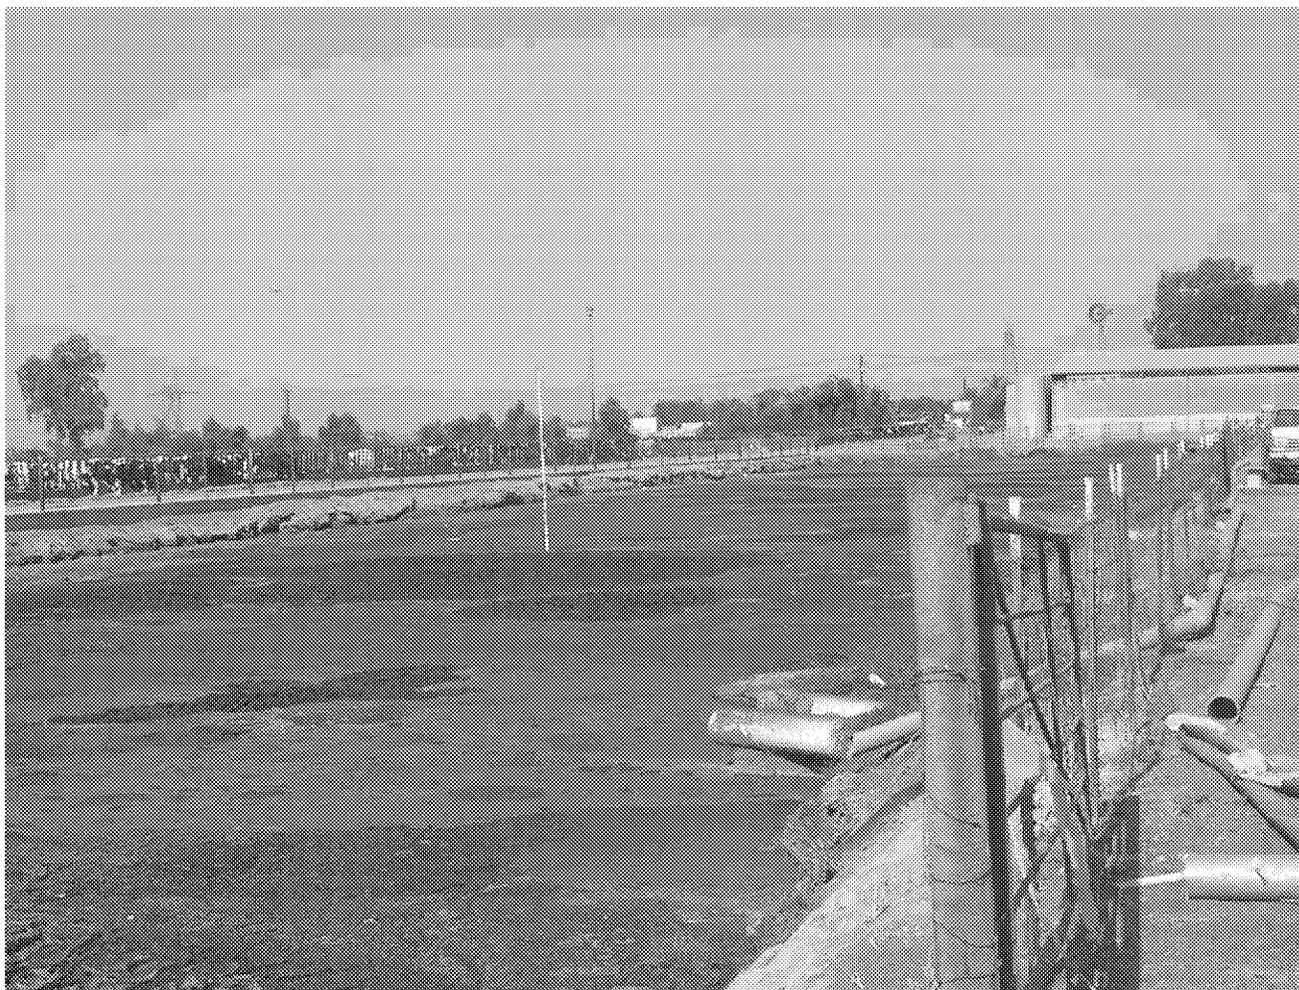
AUGUST 7, 2012 View looking west at central pond. Excessive solids floating in pond.

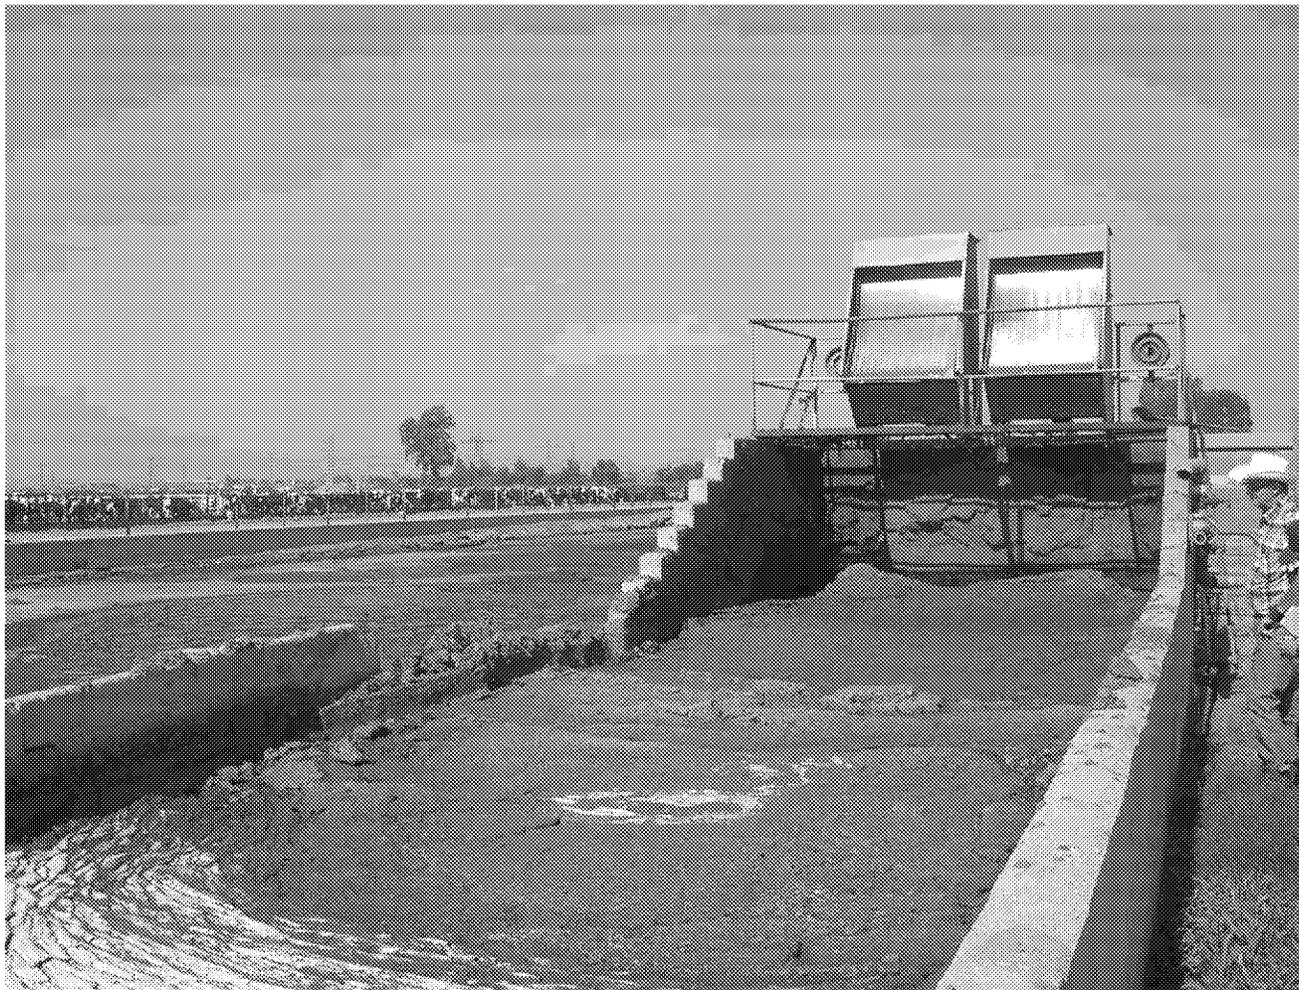
AUGUST 7, 2012 View looking west at manure separator. Excessive solids floating in pond in background.

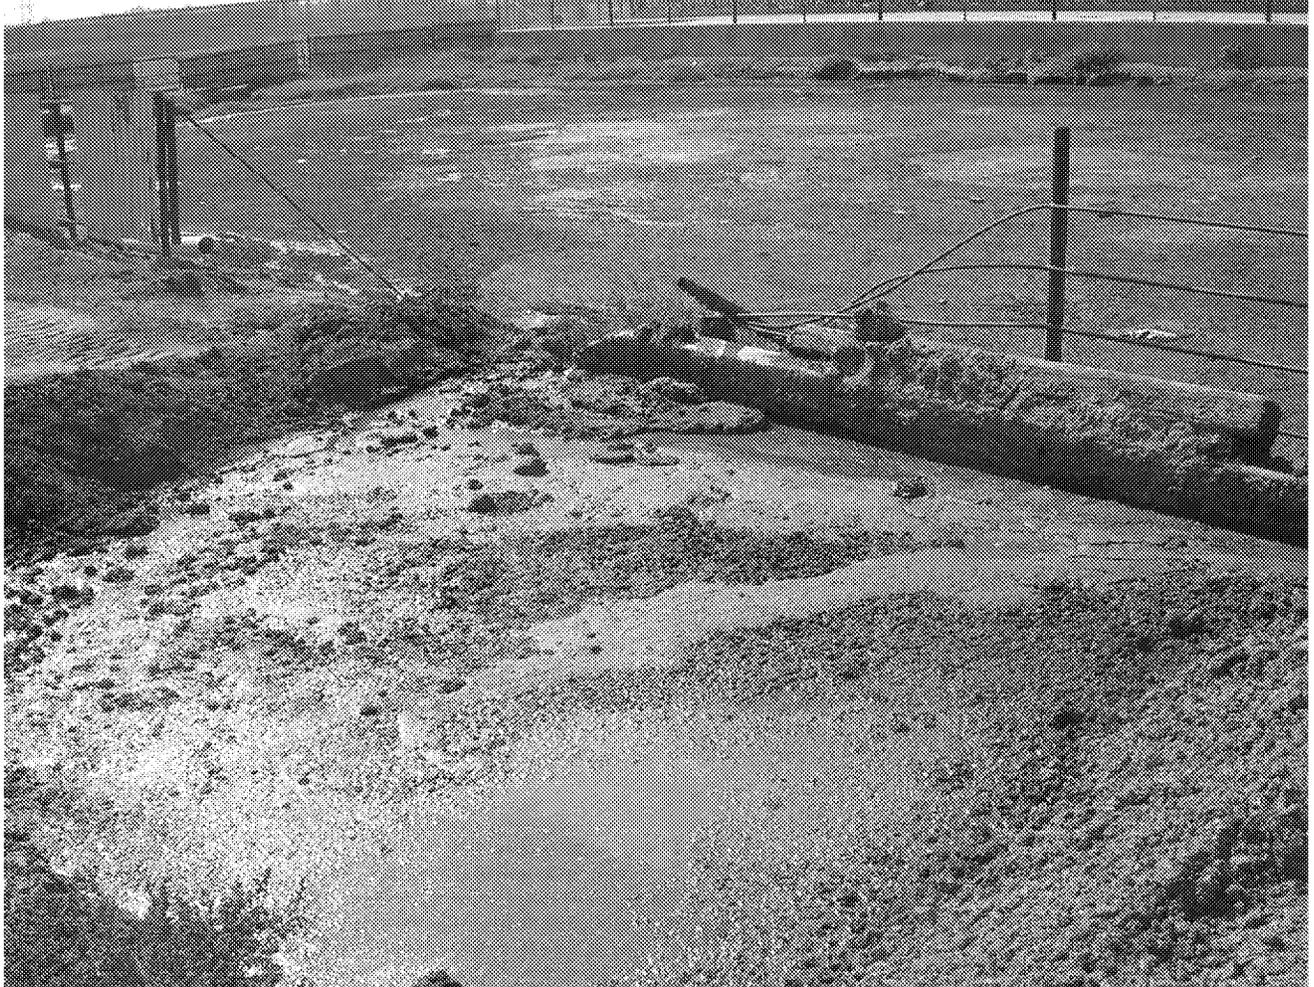
AUGUST 7, 2012 View looking southeast at central pond and manure solids storage bunker
Excessive solids floating in pond.

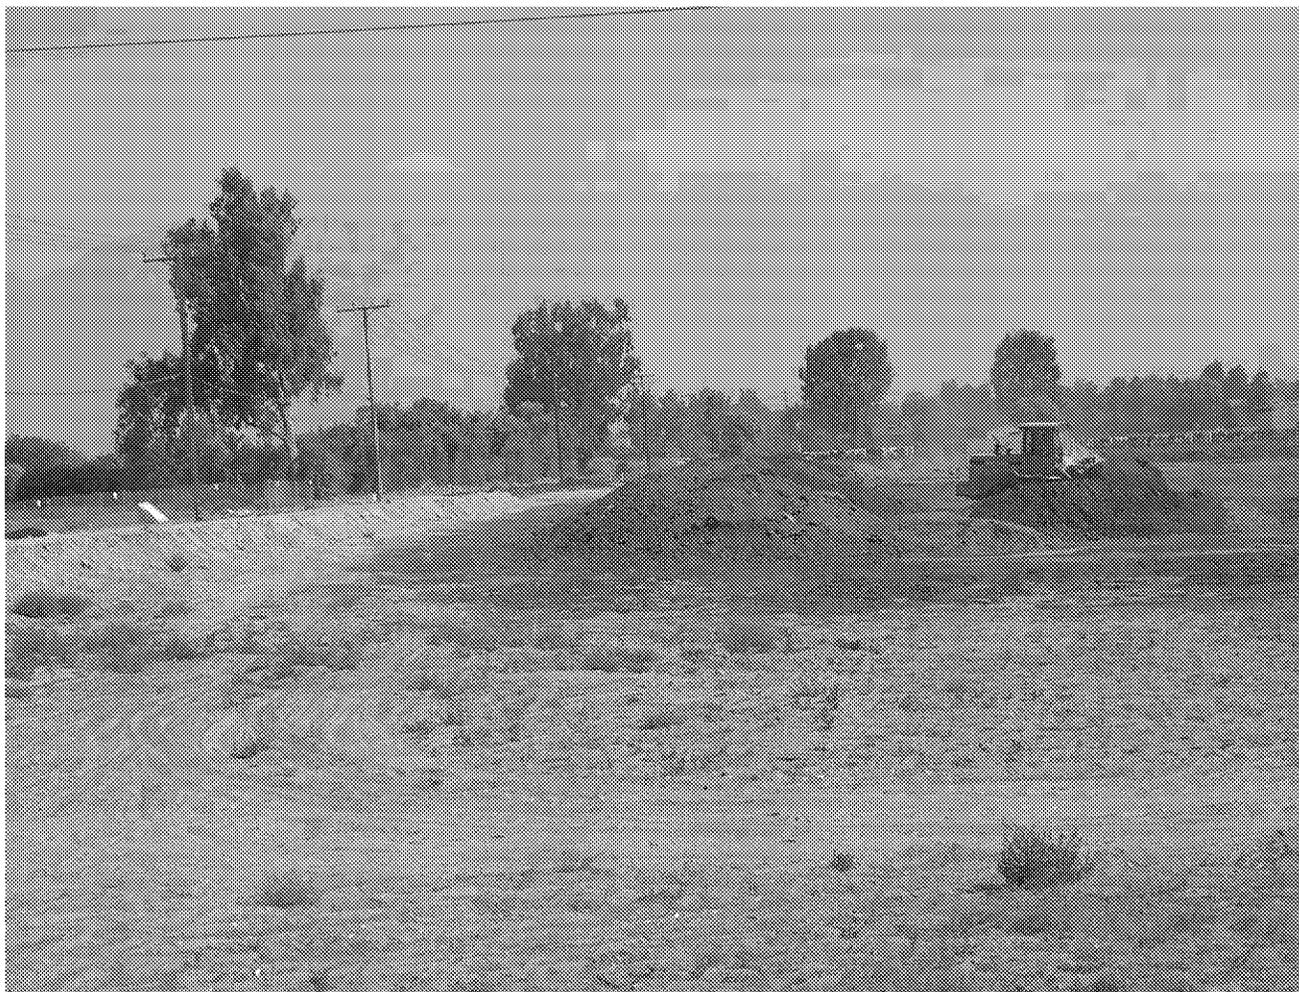
AUGUST 7, 2012 View looking north at southwest composting area.

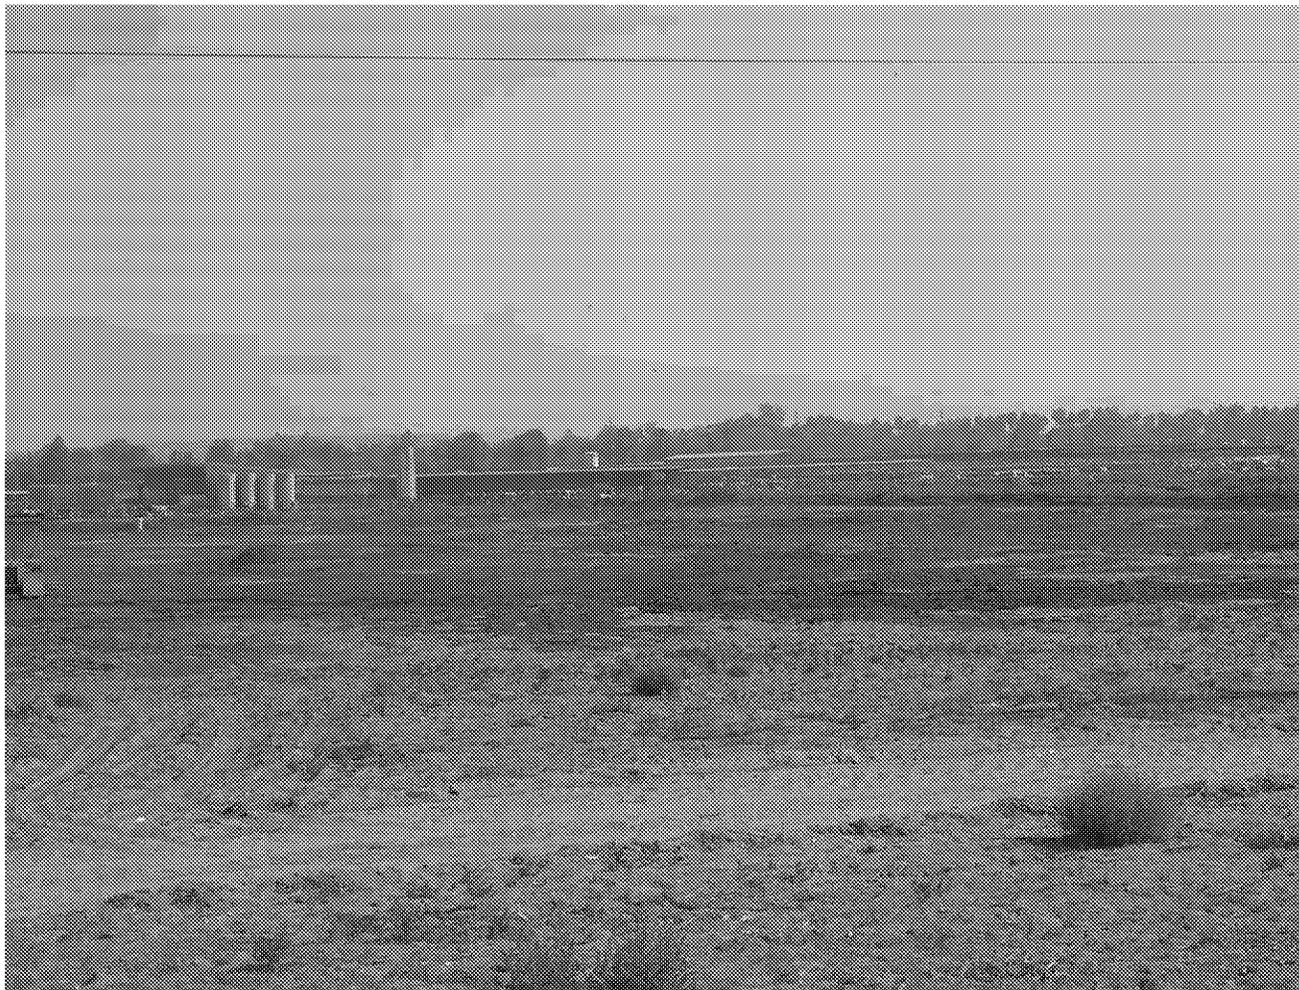
AUGUST 7, 2012 View looking northeast at southwest composting area.

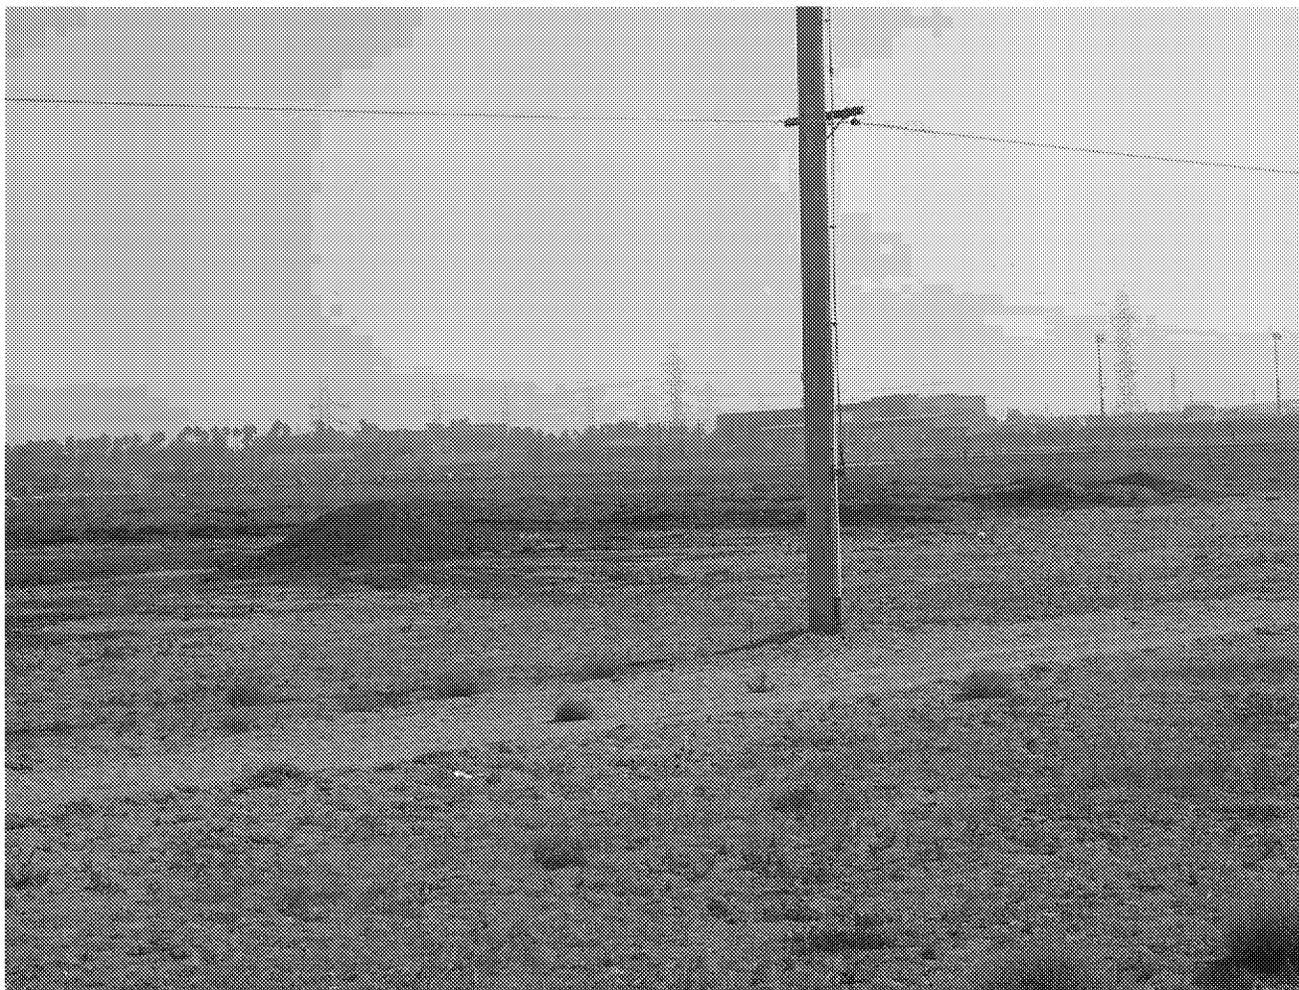
AUGUST 7, 2012 View looking north at southwest composting area.

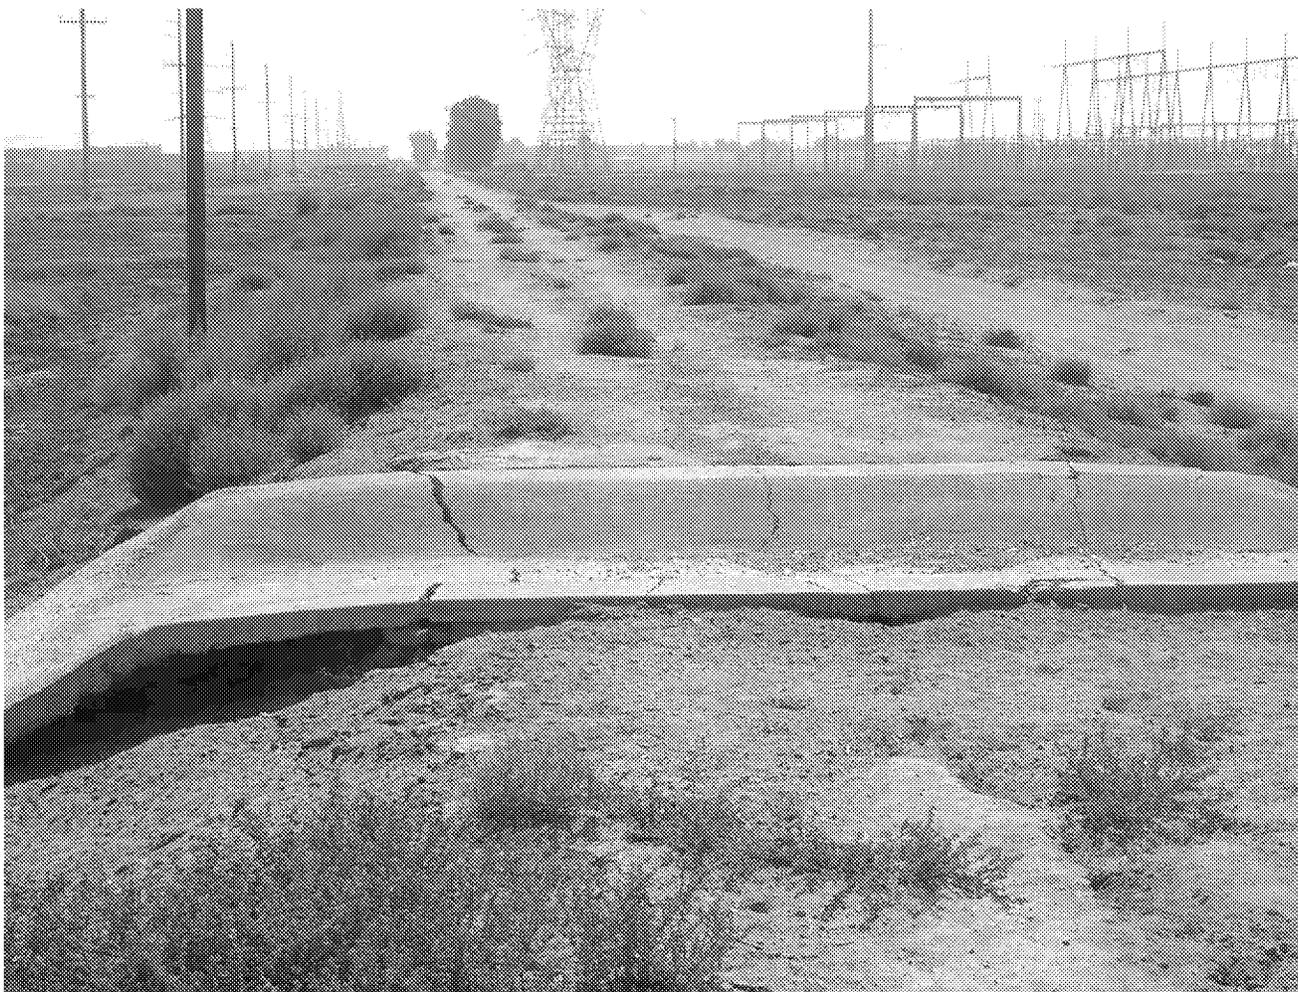
CONDITION OF BERMS AND CONTAINMENT STRUCTURES. Berm integrity appears adequate for most areas. Berm integrity at spillway area may be compromised by extensive rodent activity. Rodent activity has eroded soil around and under spillway and has caused spillway to break into sections. Minor vegetation on berms. Southeastern berm has been modified by grading activity for new road work on property east of dairy. Other than the grading work, the berm integrity appears adequate for this eastern section. Refer to Photos

AUGUST 7, 2012 View looking east along south berm. Note cracks in spillway and rodent activity around spillway.

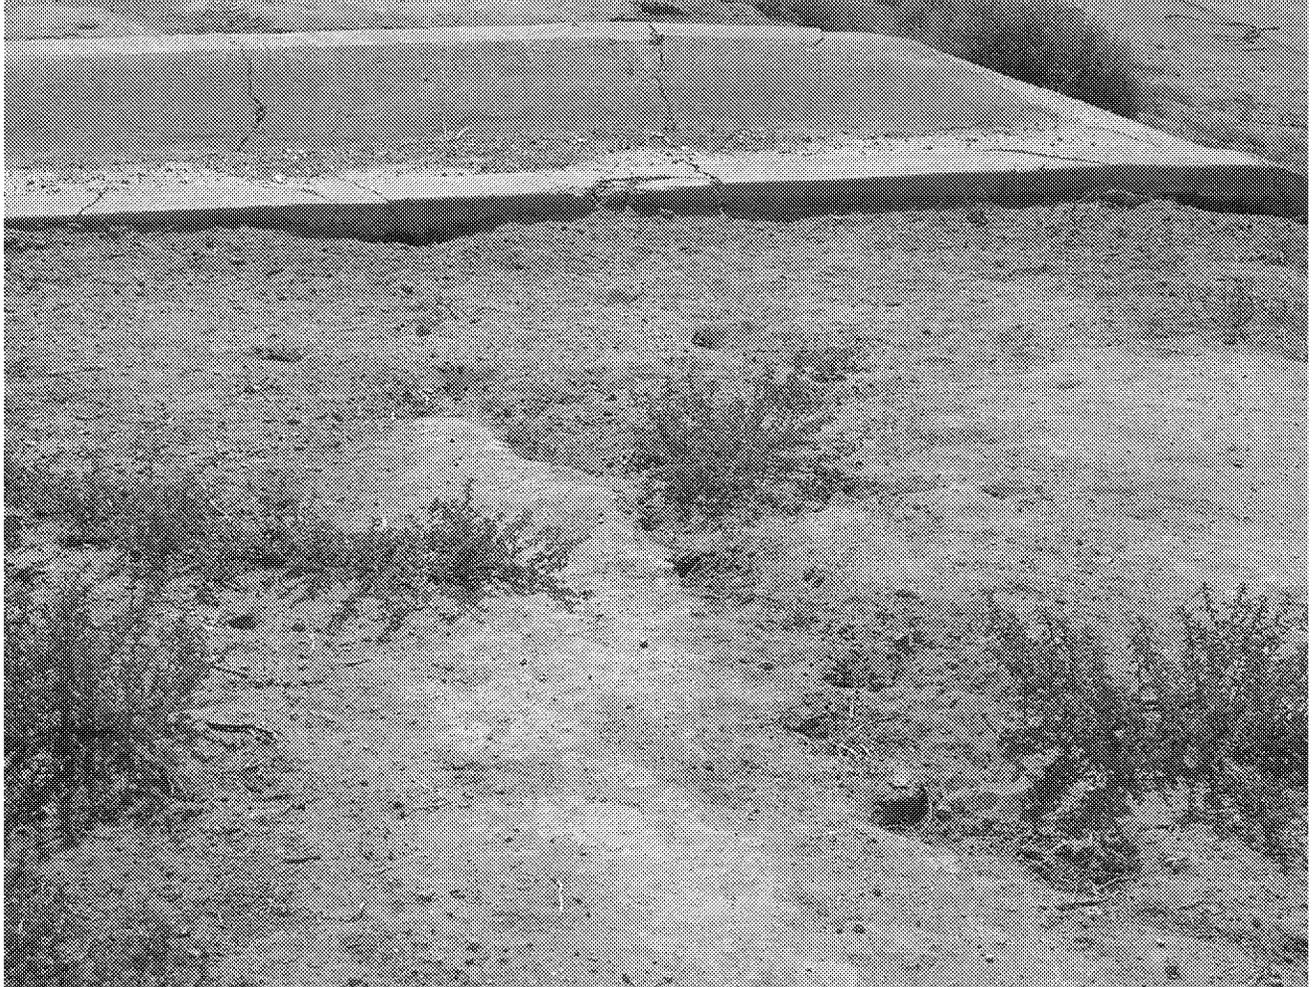
AUGUST 7, 2012 View looking east along south berm. Note cracks in spillway and rodent activity around spillway.

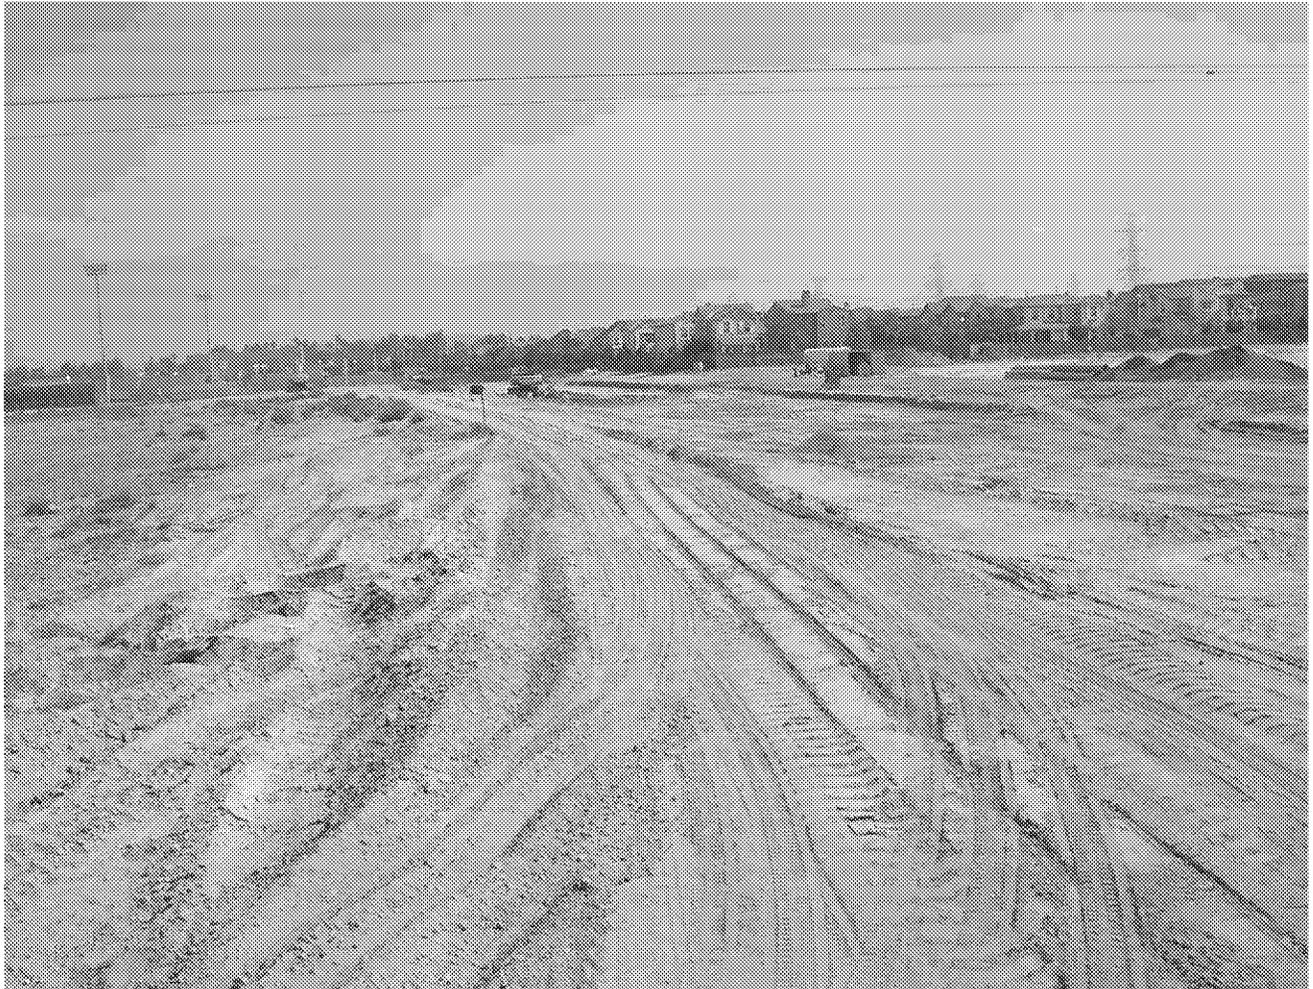
AUGUST 7, 2012 View looking north along east berm. Grading work on berm from new road construction for adjacent property (right half of photo).
